The story of a Normandy battle field find radio rack

Panzergruppe West - Raid on la Caine - Hill 112

Normandy battle field find radio rack

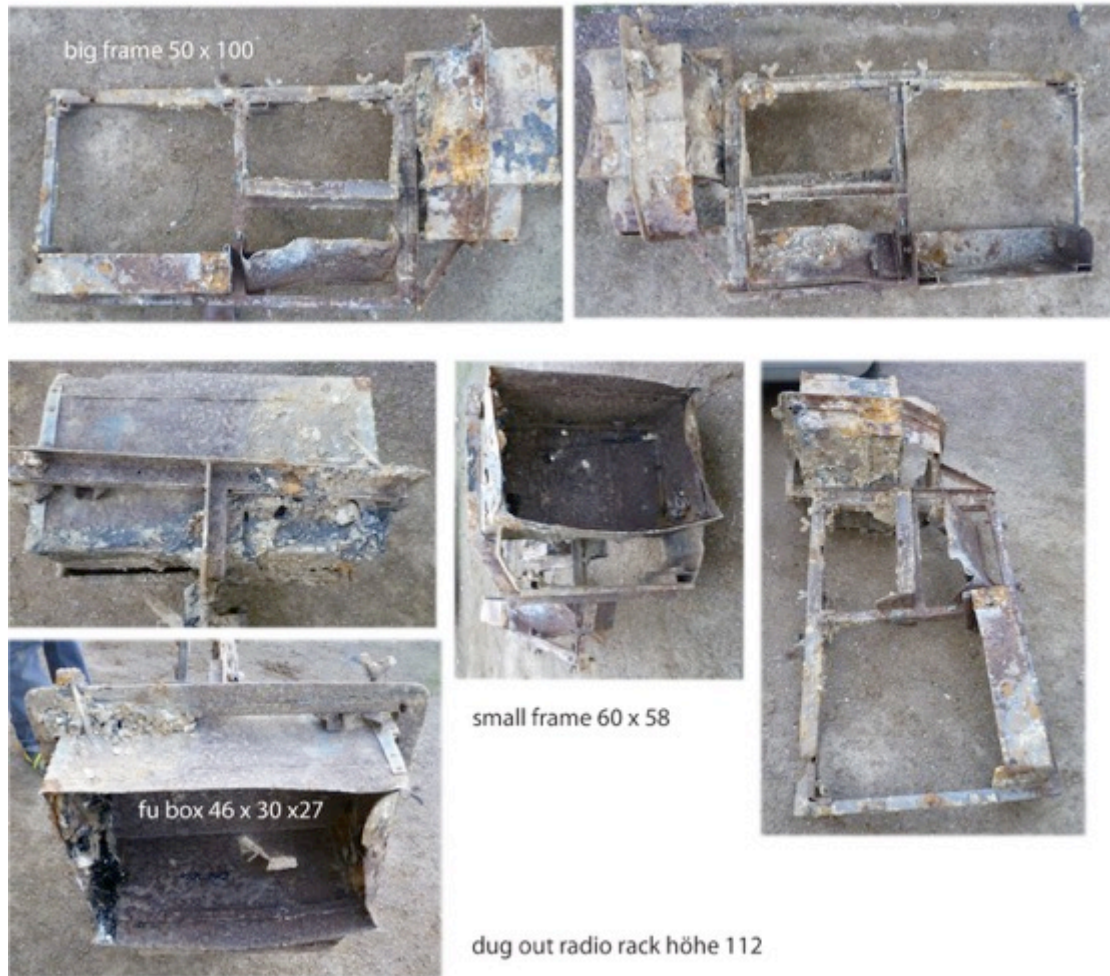
overall size 128 x 60 x 60

Figure 1: The radio rack as it emerged from a bomb crater on Hill 112.

Finding a WW2 German radio frame of any description is unusual, as most were scrapped after the war along with their vehicles.

The size and configuration of the radio mountings pointed at the rack originating from a German half track. Typically radio racks in German half-tracks (the Sd.Kfz.250 and Sd.Kfz.251 series) used tubular steel but further research confirmed that it was indeed a German radio rack of a late war type, specifically used in half-tracks of the type Sd.Kfz. 251, Ausf. D.

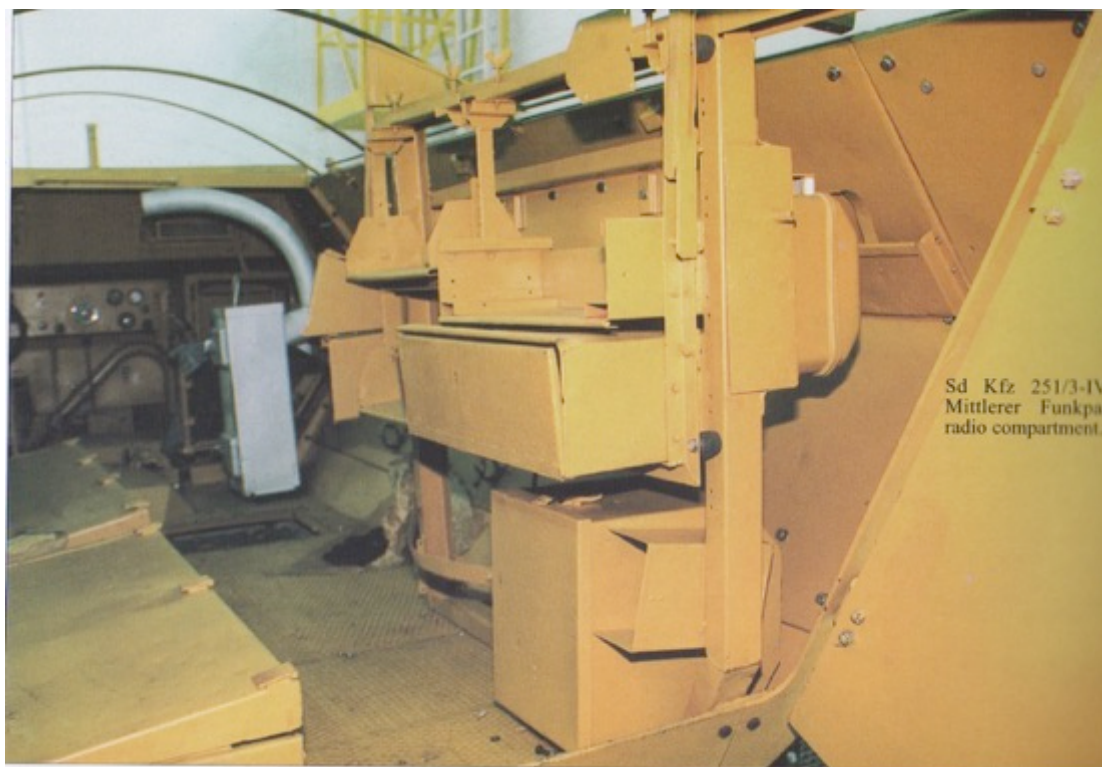
The radio frames used in late war Sd.Kfz 251 Ausf. D used simpler angular profiles. A surviving Sd.Kfz 251/3 Ausf. D found in a river in Poland illustrates a similar construction to the rack found on Hill 112.

Figure 2: Radio rack in a Sd.Kfz 251/3 Ausf.D surviving in Poland [© Sd Kfz 251 in Polish museums -Janusz Ledwoch]

The radio frame is designed to be configurable for different radio installations; by moving the position of the baseplates for the radios, different sized radios can be accommodated. The 100 W.S. takes up the whole right hand side of the frame; if a smaller 30 W.S. is fitted an additional box could be fitted underneath the transmitter as in Figure 2.

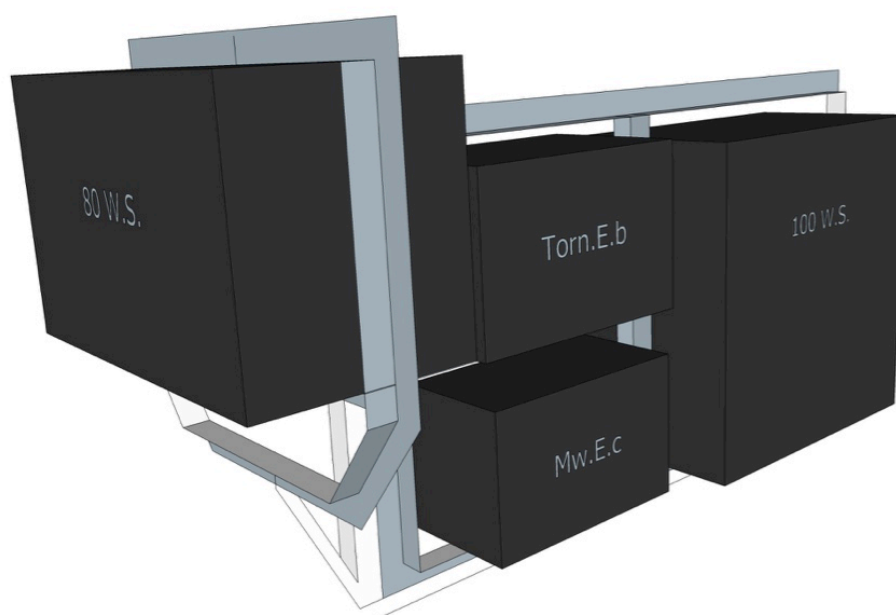
Figure 3: Reconstruction of the radio configuration

On the front was a medium wave 80 Watt transmitter (80 W.S.), on the right was a long wave 100 Watt Transmitter (100 W.S.) and in the centre were two receivers, a wideband receiver "Torn.E.b" and a medium wave receiver "Mw.E.c". These radio sets were named the Fu11SE100 (100 W.S. + Torn.E.b) and Fu12SE80 (80 W.S. + Mw.E.c)

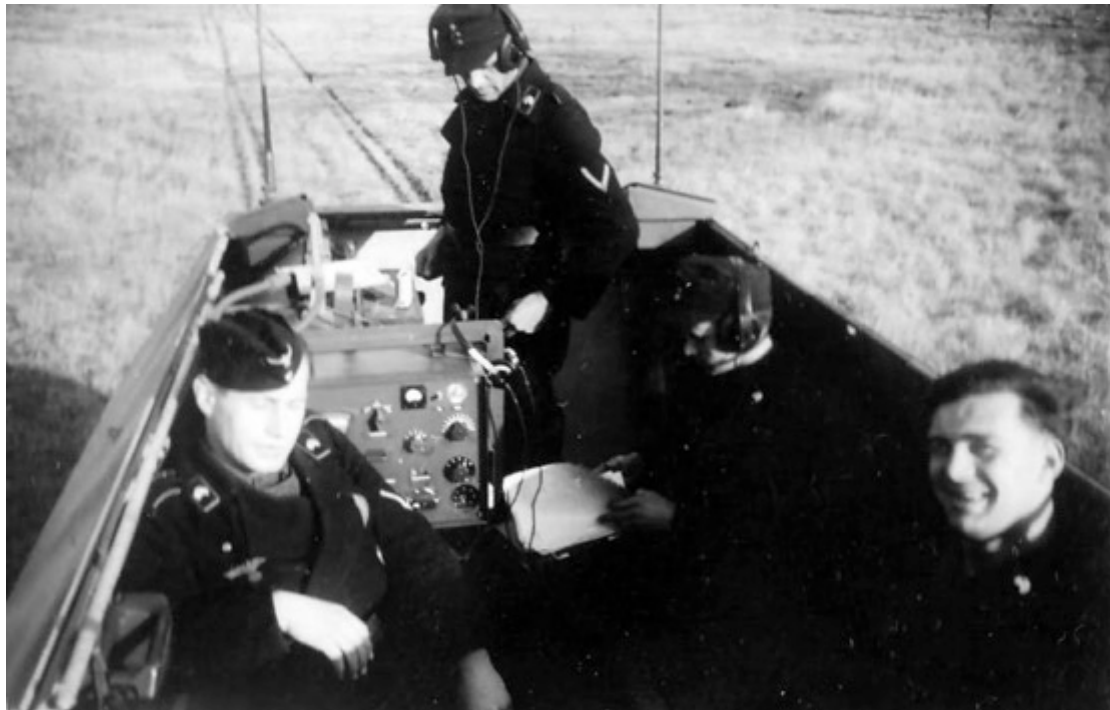
Figure 4: A period photograph of a Sd.Kfz. 251/3. Note the placement of the 80 W.S. on the front side of the radio rack. The absence of a frame antenna indicates that the remaining radio configuration was probably different. [© www.worldwarphotos.info]

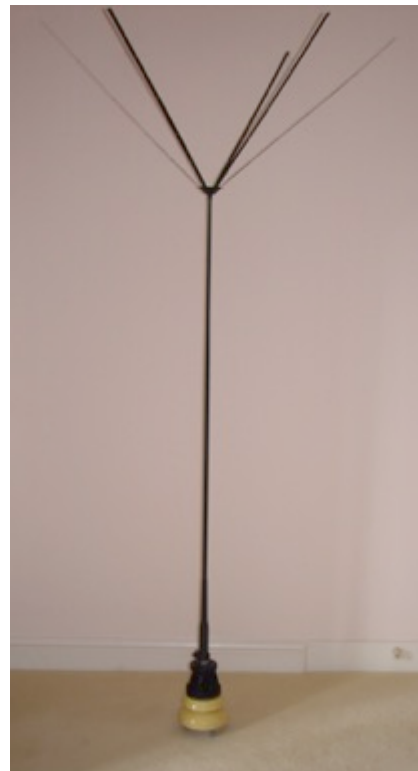
It is certain that all late war production armoured halftracks equipped with the medium wave radio sets would have been equipped with the new Sternantenne D.

Figure 6: Sternantenne D

At this point it is useful to consider the antenna configuration used by the "Kommandofunkwagen. Early in the war, most vehicles equipped with the medium wave command radios of either 30 or 80 watts used a characteristic frame antenna. This could be found on both Sd.Kfz.250 and Sd.Kfz.251 radio half-tracks of earlier types. By 1944 the frame antennas were largely replaced with a simple star antenna; the "Sternantenne D". Cheaper and less conspicuous it also proved to be a more effective antenna than the old type frame antenna.

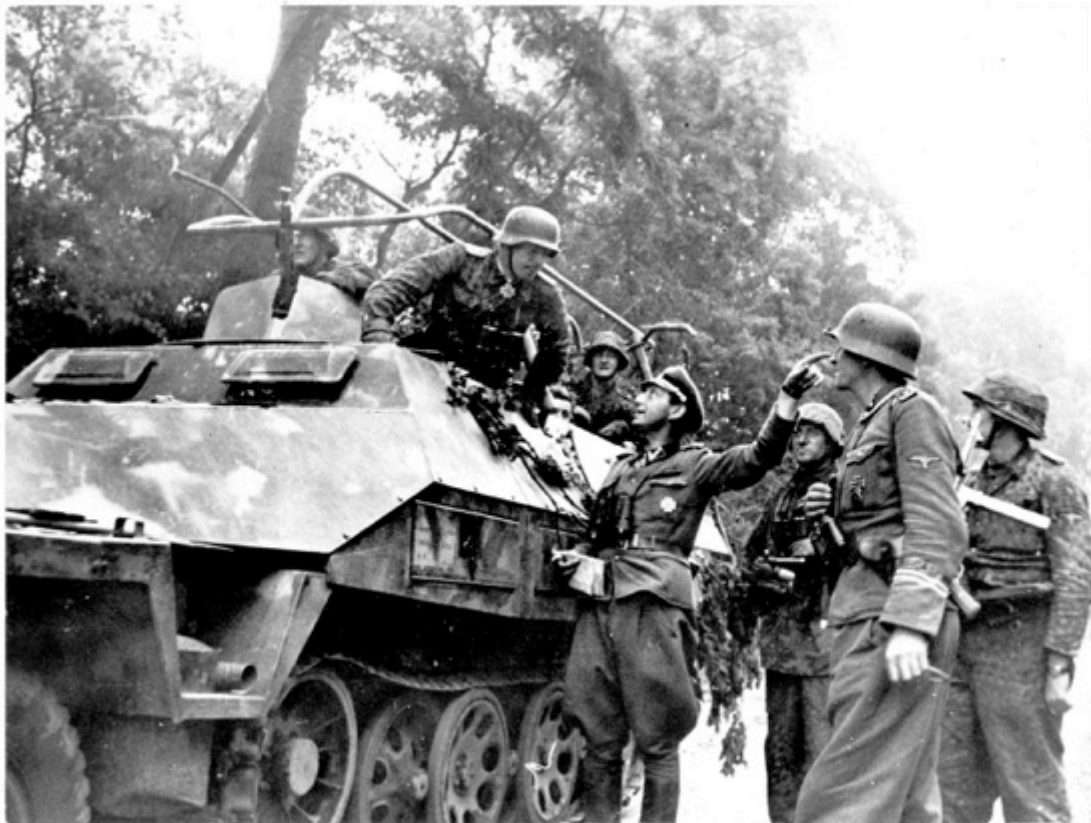
Figure 7: Heinz Harmel in his Kommandofunkwagen during the battles for Hill 112. Note the large frame antenna for the 100 W.S. [© Bundesarchiv]

However the 100 W.S. -being of longer wavelength and higher power- could not use the Sternantenne D. It would need a 9 meter telescopic mast with a larger star antenna which could only be deployed when the vehicle was stationary. To operate the Fu11SE100 radio set on the move, the vehicle would still require a frame antenna. For this reason the Sd.Kfz. 251/4 IV probably was the only Sd.Kfz.251 Ausf.D fitted with frame antenna, making the vehicle easily recognisable.

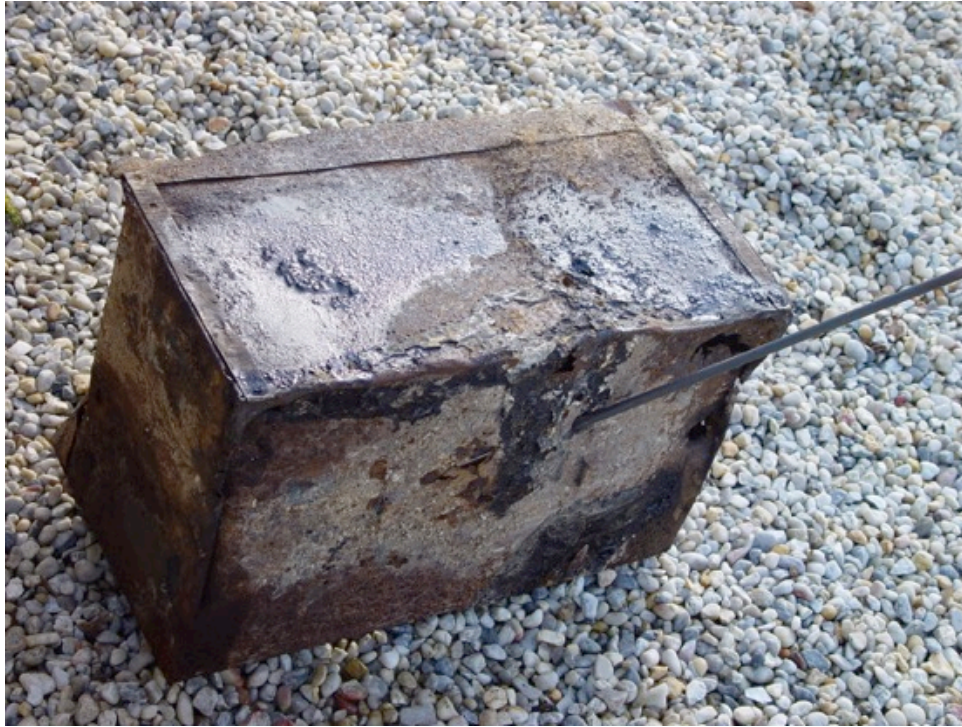
A closer inspection of the rack revealed impact damage on at least two locations. The 80 W.S. has at least one (possibly two) bullet entry holes in the back and a large exit hole in the bottom of the case:

Figure 8: 80 W.S. case showing the approximate impact angle.

The 80 W.S. was hit from quite a high angle from the rear right side of the vehicle

Both bullet entry holes measured approximately 20 mm. This provides strong indications that the vehicle was hit by cannon fire from the air during a strafing attack. The differing angles suggest that the two transmitters were hit during different passes.

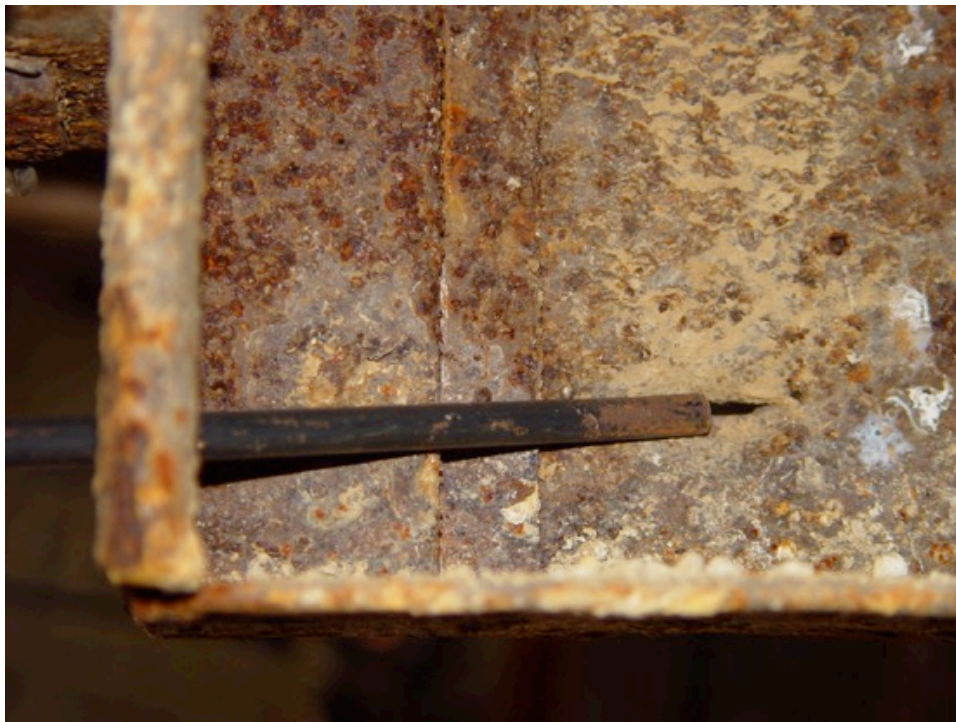
Figure 9: Approximate trajectory of bullet hitting the bottom tray of the 100 W.S. rack.

On the 100 W.S., the bullet entered the rear of the support tray for the 100 W.S. and dented the bottom of the tray. The bullet did not have enough energy to exit through the bottom. The 100 W.S. would definitely have been put out of action by

this damage. Again the trajectory was from a high angle (albeit lower than on the 80 W.S.) from the right rear of the vehicle.

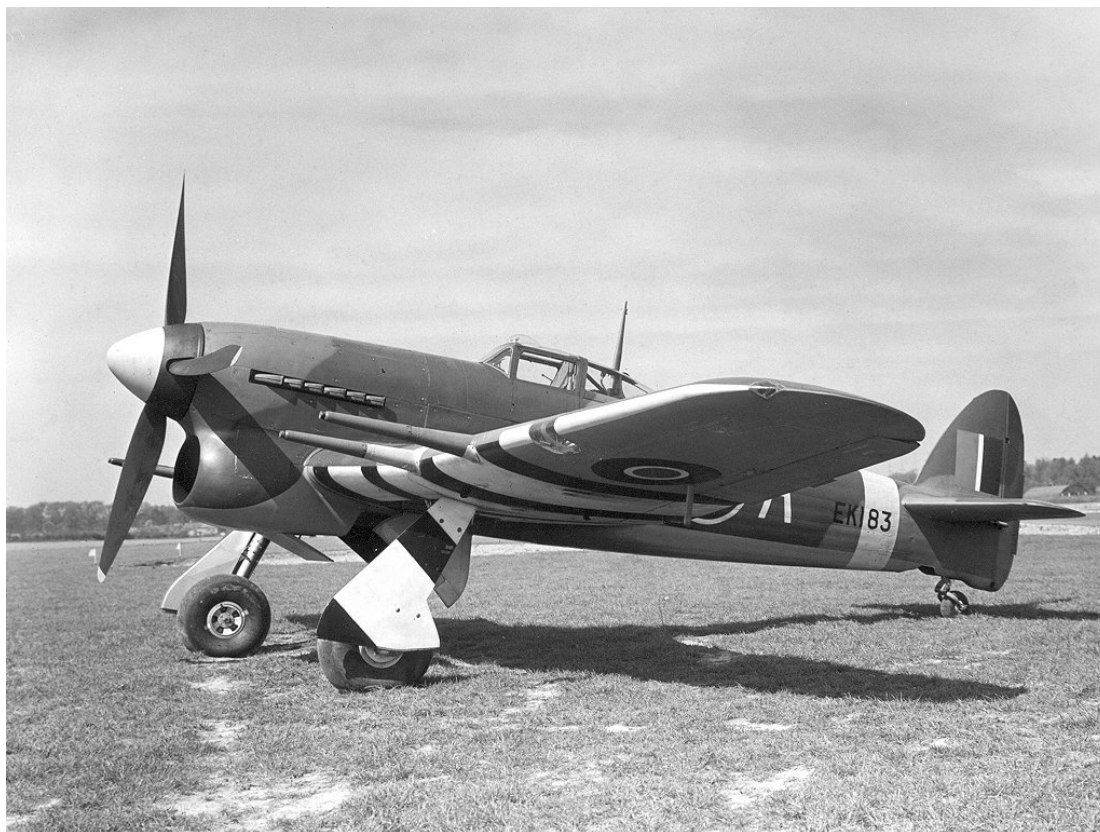
Figure 11: Hawker Typhoon with the typical black and white invasion stripes used during the Normandy battle. Note the four 20mm cannon protruding from the wing. (© www.Globalaviationresource.com)

On 10 July, the RAF attacked Geyr von Schweppenburg's HQ in la Caine, some 8 km behind Hill 112. 61 B-25 Mitchells bombed the area while 40 Typhoons conducted strafing attacks and fired rockets. Typhoons were fitted with 20-mm cannon, which are a prime suspect for the damage inflicted on the radio rack.

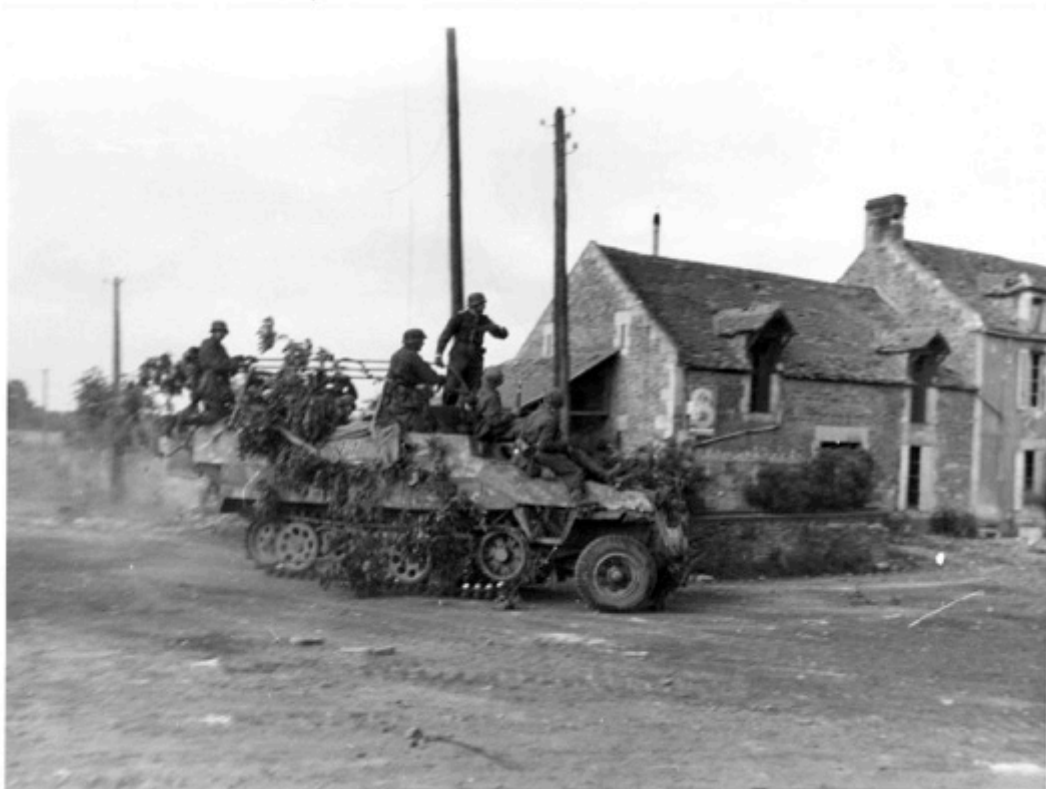
Figure 12: Harmel's Kommandofunkwagen in Normandy. Part of the tactical number "211" is visible on the side. The complete marking was probably "N211" denoting the first vehicle in the first platoon of the second (radio) company of the Signals regiment. [© Bundesarchiv]

The use of a Sd.Kfz. 251/3 Ausf.D by Heinz Harmel -commander of the 10th SS Panzer Division "Frundsberg"- during the battles for Hill 112 is well documented. Figures 10 and 11 show the vehicle in use. Below another sideways view, the sloping rear of the late war Ausf. D can just be recognised:

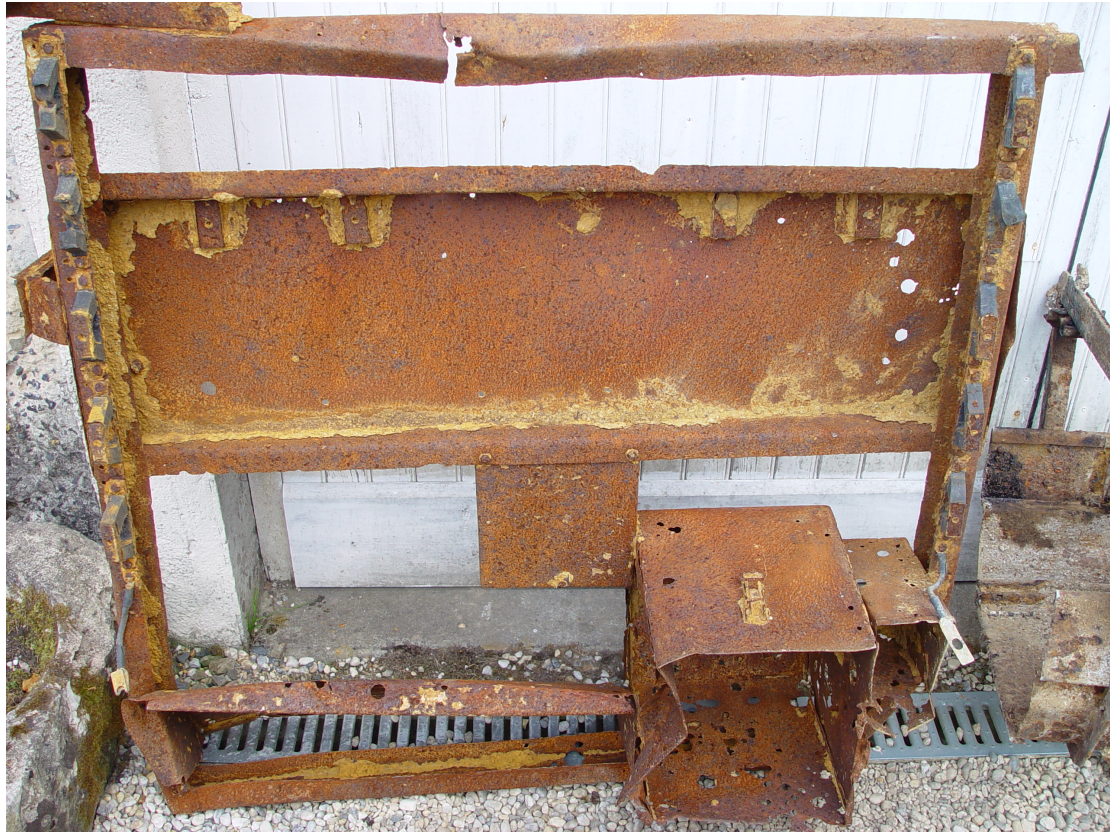
Figure 13: Another rack found in Normandy included the support frame,; the frame found on Hill 112 would have been fitted to an identical support frame.

All the power supplies and auxiliaries for the radios were found to fit exactly to the fixtures on the support rack. The radio rack itself was fitted to the support rack with rubber buffers, the remains of which can be seen on the vertical beams of the support rack. A box welded to the bottom right of the support frame was found to fit a GG400 generator. All this information allowed us to recreate the completeradio installation as fitted to the Kommandofunkwagen.

Rather than clean and patch up the radio rack, the decision was taken to keep the rack in it's original condition and create a copy of the rack to the exact measurements. This recreation was helped by the discovery of a similar radio rack in a different region of Normandy. Even though the radio configuration of this second find differed from that of the Kommandofunkwagen rack, it provided accurate measurements of the the support rack to which the Hill 112 rack was once fitted:

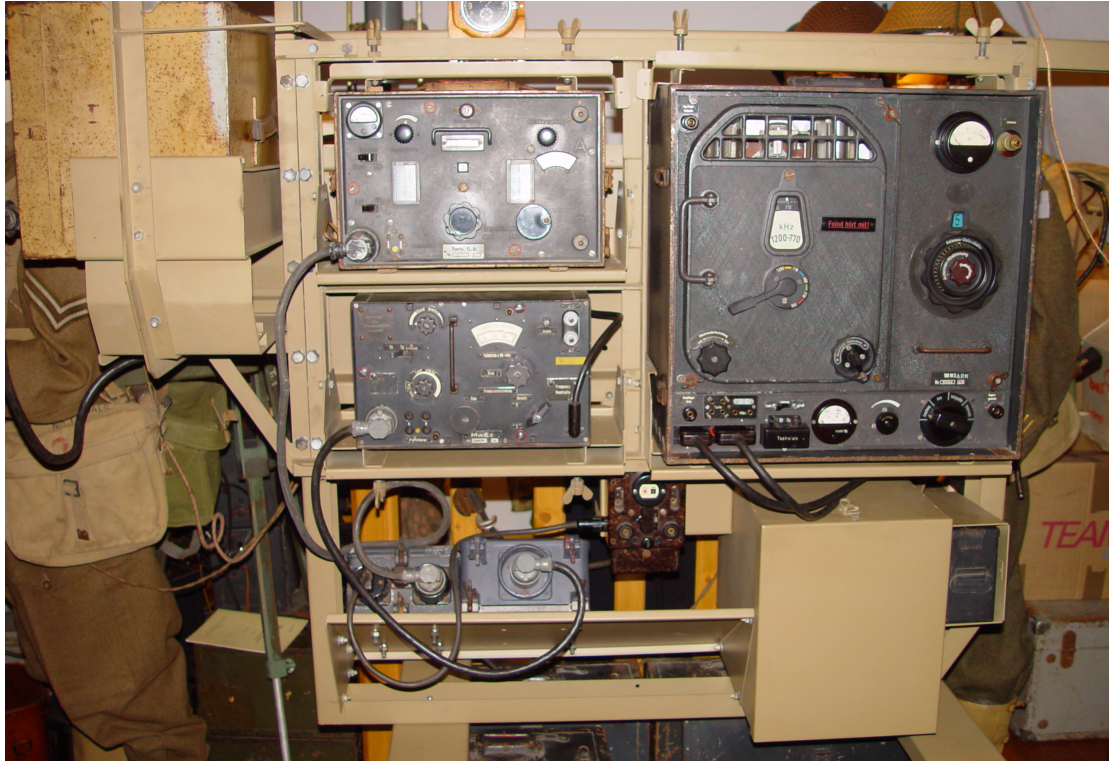
Figure 14: Front view of Geyr von Schweppenburg's Kommandofunkwagen radio installation. The front view shows the Torn.E.b and 100 W.S. of the Fu11SE100 and the Mw.E.c of the Fu12SE80, the 80 W.S. is soon from the side on the far left of the picture.

The radios are held in place by metal profiles tightened by the large wing nuts visible above and below the frame. The power supplies are fastened to the support frame (receiver power supplies below the radios, transmitter power supplies on the back of the frame).

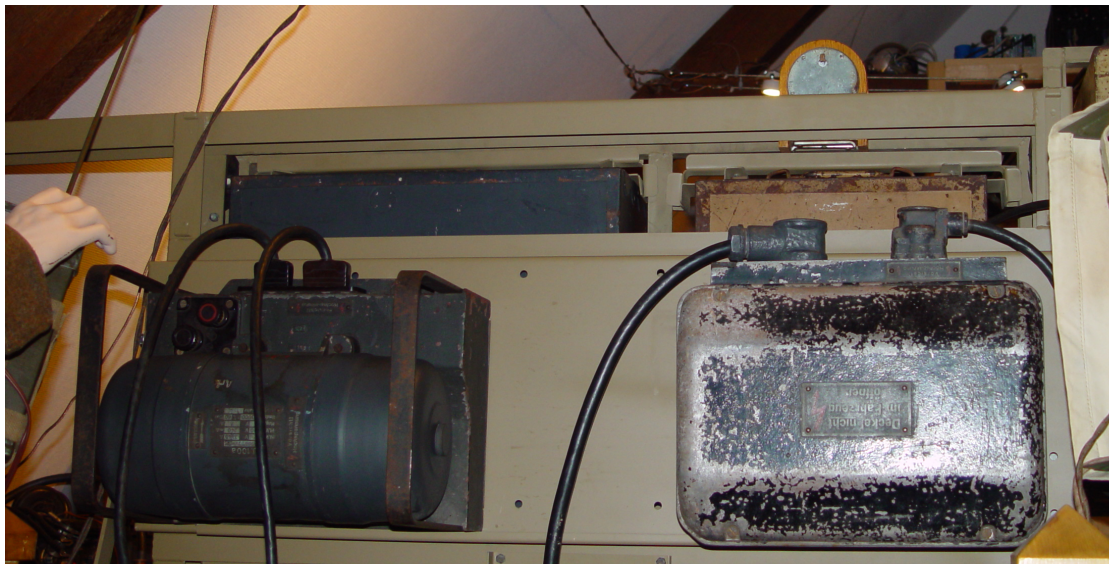
Figure 15: Rear view of the radio installation showing the power supplies for the two transmitters.

The power supplies slot into a ridge below and are fixed by two bolts at the top. The following photograph shows the storage box of the GG400 generator. This generator would be placed outside the vehicle when stationary to provide power for the radios, sparing the vehicle's batteries.

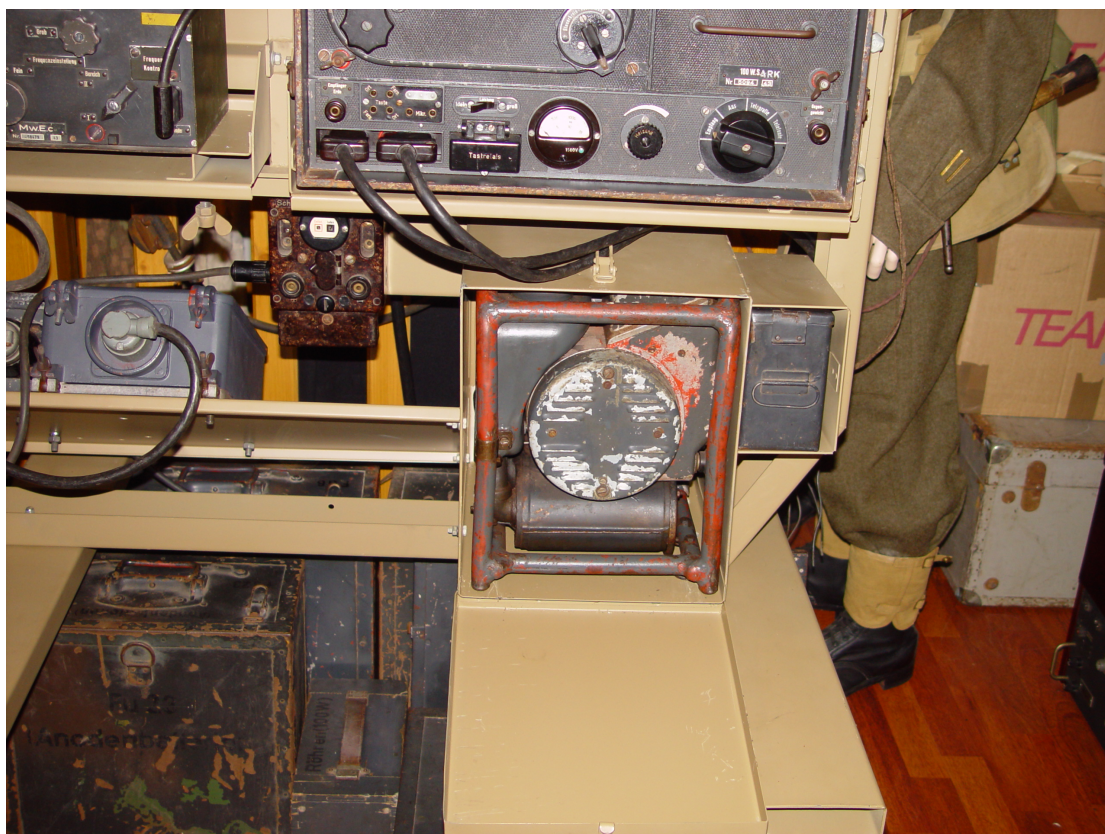
Figure 16: Detail of the storage box for the GG400 generator.

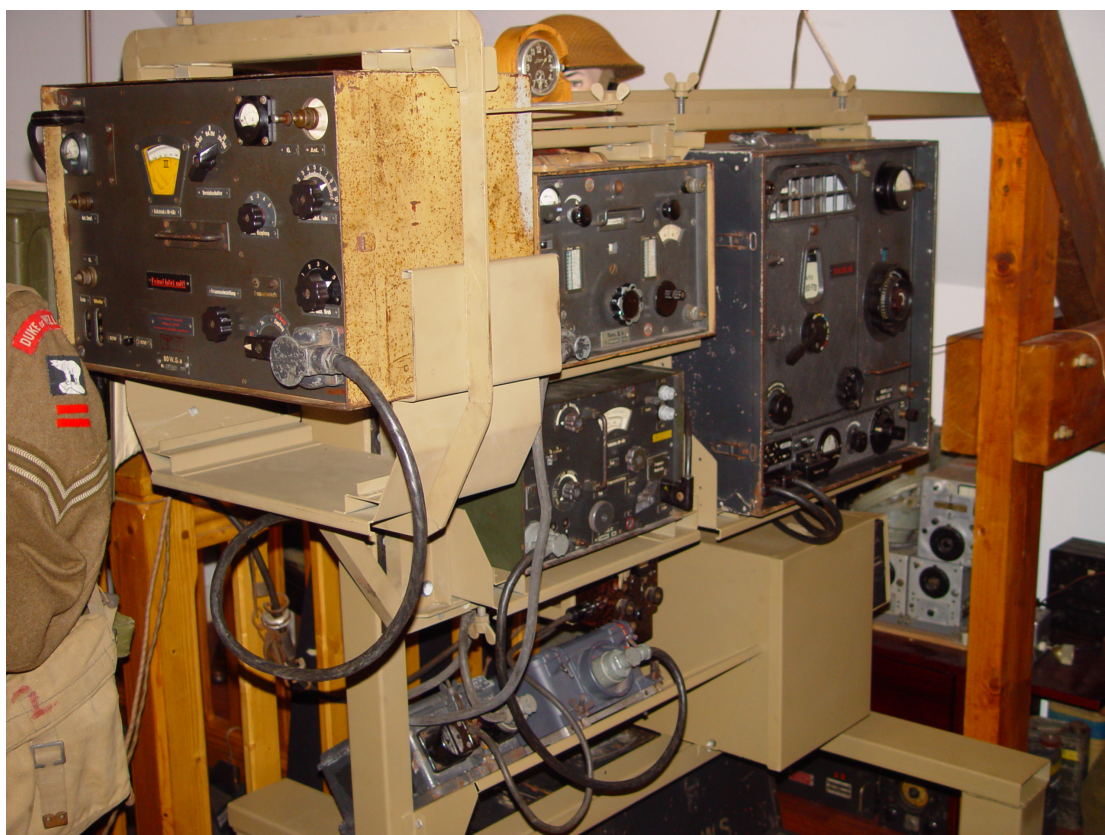
Figure 17: Left 3/4 view of the radio installation, showing the position of the 80 W.S. transmitter of the Fu12SE80.

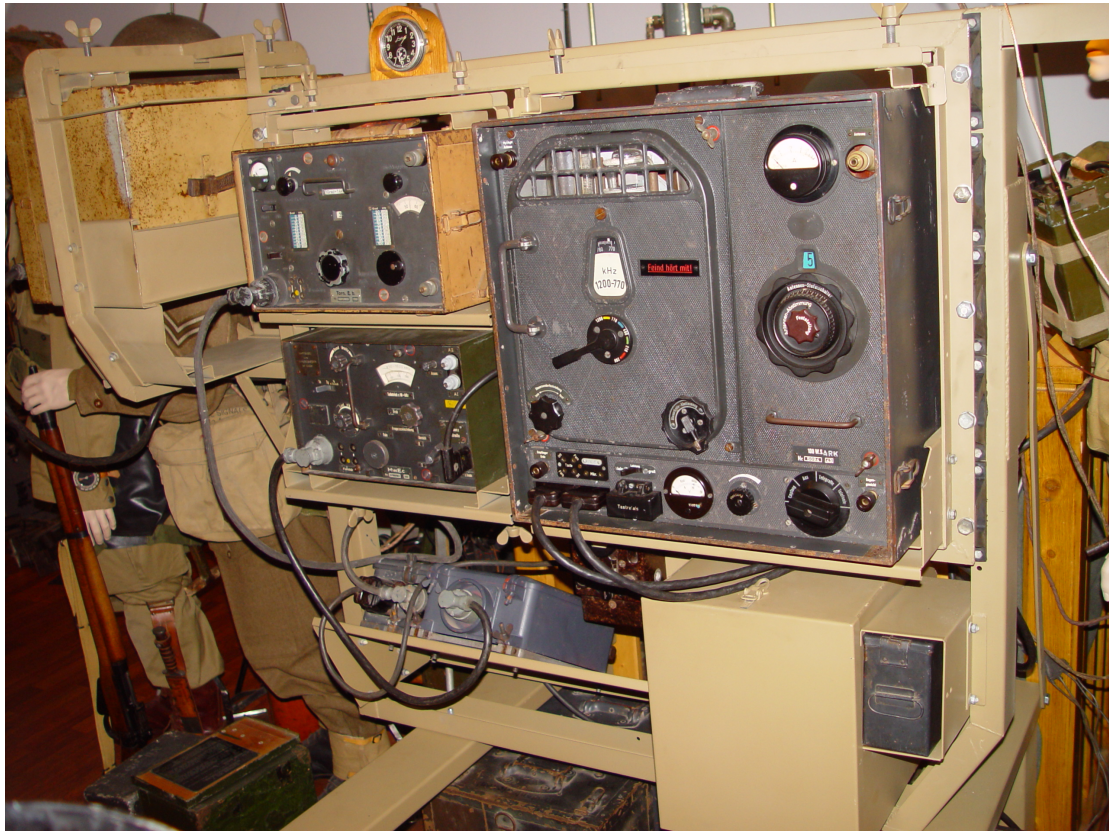
Figure 18: Right 3/4 view of the radio installation. The front view shows the Torn.E.b and 100 W.S. of the Fu11SE100 and the Mw.E.c of the Fu12SE80, the 80 W.S. is soon from the side on the far left of the picture.
